Cite as: AIP Conference Proceedings **2245**, 100002 (2020); https://doi.org/10.1063/5.0012456 Published Online: 08 July 2020

Distribution of Acidic Condition of River Water from The Ijen Active Volcano Crater in Banyupait River Asembagus Situbondo, East Java, Indonesia

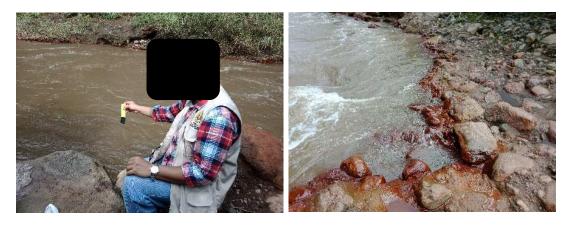
FIGURE 2. The pH measurement of Banyupait river water (left image). The river's ground rocks have oxidation due to acidic water reactions (right image).

Water sampling was taken along the flow of Banyupait (FIGURE 2), which was passed through Bantal, Banyuputih, and Sumberejo village. pH measurement is performed against 9 locations and the result of a range between 2.7-5.5 (FIGURE 5a). It shows the magnitude of a pH acid. The water was acidic, due to the seepage of the crater Ijen. According to [13] the Banyupait water river has pH of between 2.6 – 4.2. According to [13] in 1921 a dam was built on the west bank of the crater. The function of this dam was not only to control crater lake water when it was high, but also to move acid water into the downstream area. During these decades, dam floodgates have not been used, because lake surface water remains below the dam. The sulfuric acid water containing chlorine leaks through rock pores in several locations under the dam, and the total discharge of acidic water that comes out was around 50 L / T. Acidic water from upstream flows through the Banyupait river, then down the volcanic slope through settlements in Paltuding and Watucapil. Acidic wastewater with a pH of 2.5-4.5 [13] containing high concentrations of elements polluting the river downstream used by residents for irrigation [14, 15] of the 3600 ha plantations in Asembagus, which are mostly used for sugar cane, rice and corn plantations. While the pH measurement of water on the downstream the Banyupait river (FIGURE 5a), in east Sukorejo indicates that the pH of seawater was neutral (pH 7.7). It was due to the water of the Banyupait river acid mixed with seawater, so the pH becomes neutral.
